This document details known errata for the following silicon:

| Product | Revision | Description | Status |
|---|---|---|---|
| PEX8605 | AA | 4-Lane, 4-Port PCI Express Switch | Full Production |

### D. Errata Summary

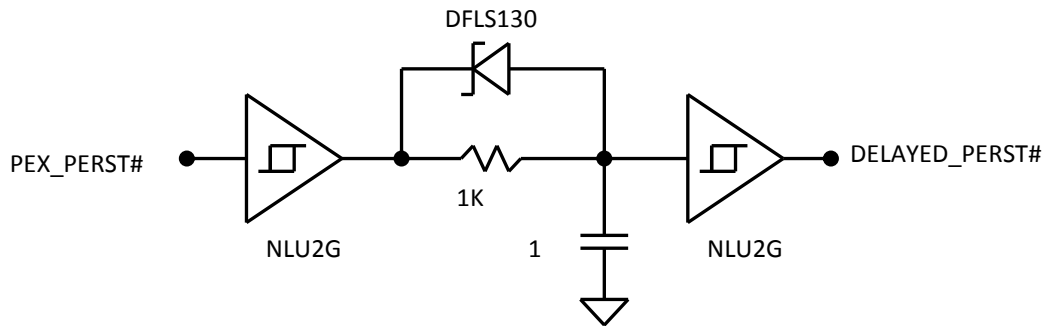
At initial power-on, valid clock may not appear at the PEX\_REFCLK\_OUTpx/nx output pins, even while a valid clock is present on the PEX\_REFCLKp/n input pins, until 900 us after PEX\_PERST# input pin is de-asserted. Because PCI Express devices attached to the downstream ports of the switch require their input clocks to be valid for 100 us prior to de-assertion of PERST# (per PCI Express specifications), it is not possible for both PEX8605 and its downstream devices to share a common reset line.

**Figure 1.** An example circuit to create a delayed version of PEX\_PERST# for downstream devices.

Downstream PCI Express devices may not reset correctly when PEX8605 and downstream devices share a common reset line.

Workaround options may vary depending on the application. For any workaround implemented, PERST# de-assertion on the downstream device must be delayed by at least 1 ms from PEX\_PERST# input.

1. Use separate signals for driving PEX\_PERST# and PERST# for the downstream devices. Design the system so that PERST# on the downstream device remains asserted at least 1 ms after PEX\_PERST# is de-asserted.
2. Use GPIO[3:1] output pins for driving PERST# to downstream devices. In this option, firmware must first configure the PEX8605 GPIO pins (default function for GPIO[3:0] pins is LANE\_GOOD[3:0]), program the GPIO pin to toggle low then high, and then configure downstream devices.
3. Create a delayed version of PEX\_PERST# using a delay circuit such as the one shown in Figure 1 below. This circuit delays the rising edge of PEX\_PERST# input by approximately 1 ms. Adjust resistor/capacitor values as needed to produce the required delay.
