PEX 8505

PCI Express Switch

Silicon Revisions and Errata List

Version 1.1

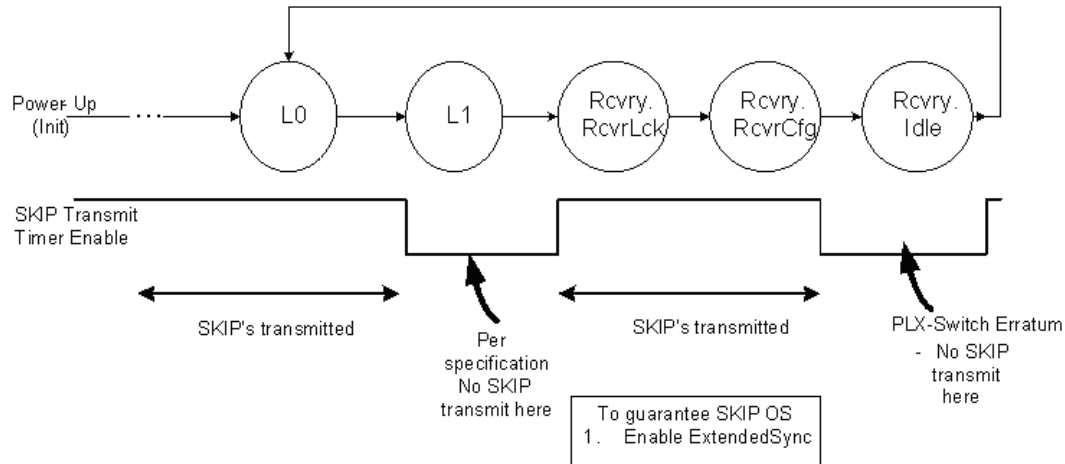
When exiting from the L1 Power Management (PM) state, there is a narrow window (recovery.idle state) during which SKIP ordered sets are not transmitted. The exit from L1 PM state steps through 3 sub-states:

- 1) rcvry.rcvrlock
- 2) rcvry.rcvrconfig
- 3) rcvry.idle.

For the duration in which the link is in Recovery.idle state (waiting for receipt of 8 Idle symbols) there will be no SKIP ordered sets transmitted. Note, SKIP symbols will be transmitted properly when entries into recovery sub-states are from another (L0 or L0s) state.

The Figure below illustrates the behavior.

One of the following workarounds can be used with upstream devices whose PHYs require SKIP ordered sets to exit its L1 state.

1. Disable the PEX 8505 upstream port's entry to L1 state for ASPM L1 [78h[1:0]] and PCI PM (device specific offset 1E0[7]) mechanisms.
2. Enable the ExtendedSync mode (Offset 78h[7]), to guarantee SKIP ordered sets in the RcvrLck and RcvrCfg states (shown above)
