PEX 8508

PCI Express Switch

Silicon Revisions and Errata List

Version 1.7

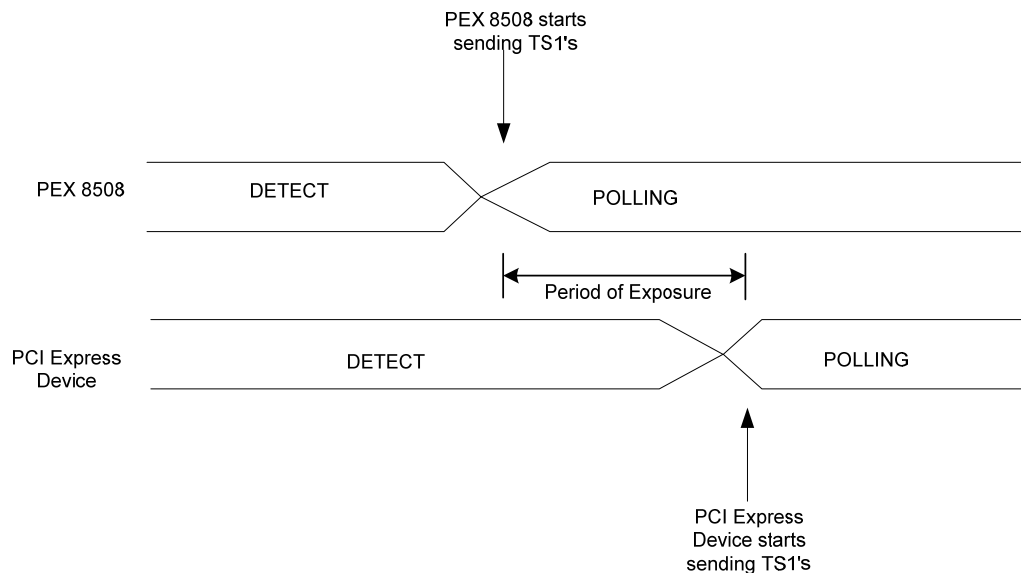
When the PEX 8508 is connected to devices that start transmitting training sets to the PEX 8508 after the PEX 8508 has been transmitting training sets (PEX 8508 in Polling state), there is a period of exposure where the receivers in the PEX 8508 are in 'electrical idle' state while the transmitters in the PEX 8508 are sending valid data. During this period the Elastic Buffer could be set in a state that prevents the lane from participating in the final link configuration.

The PEX 8508 link may down-train to a smaller width when it enters the Polling state.

1. Use Different Reference clocks. The Elastic Buffer is able to recover from this condition in the Polling state when different reference clocks are used. The link will be reliable once it transitions to the Active state.
2. Re-start training sequence on link. When the adjacent device attempts to train at a link width less than its programmed width, the PEX 8508 port can be instructed to re-start its link training sequence by issuing a link disable closely followed by a link enable. The PEX 8508 link can be disabled/enabled via register 0x78 bit 4 of the appropriate port configuration space.
3. Skew the reset inputs such that the adjacent device starts transmitting ordered sets first. The Elastic Buffer will not enter the illegal state when the PEX 8508 detects valid data on its receiver lanes during its transition from Detect state to Polling state.

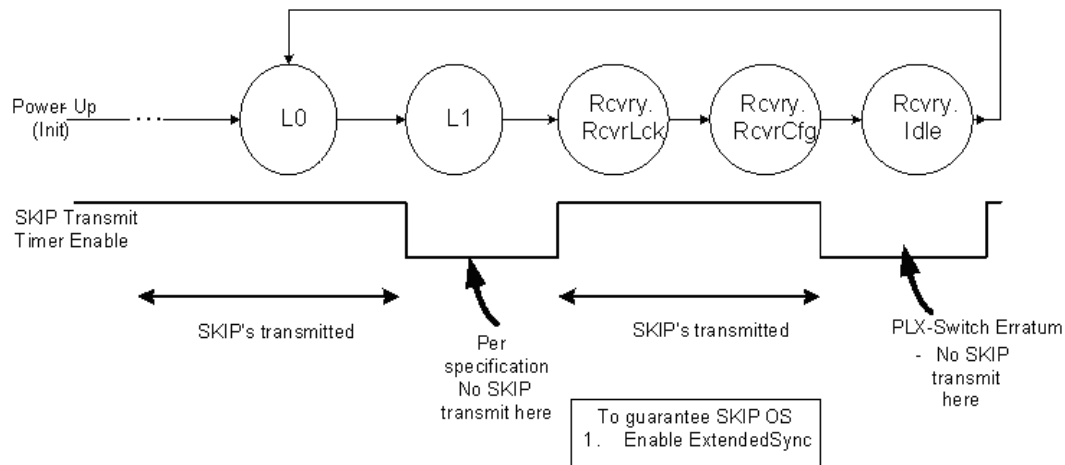
When exiting from the L1 Power Management (PM) state, there is a narrow window (recovery.idle state) during which SKIP ordered sets are not transmitted by the PEX8508. The exit from L1 PM state steps through 3 sub-states:

For the duration in which the link is in Recovery.idle state (waiting for receipt of 8 Idle symbols) there are no SKIP ordered sets transmitted by the PEX8508. Note that SKIP

The Figure below illustrates the behavior.

PCI Express devices whose PHY require SKIP ordered sets to deskew and also to exit the recovery path shown above could fail L1 entry/exit and reach the L0 state >100ms later; consequently, taking the link down along the way. The workarounds listed above can be used to prevent the failing case. Note that when using Workaround 1, the PEX 8508 will not realize any L1 power savings.

One of the following workarounds can be used with upstream devices whose PHYs require SKIP ordered sets to exit its L1 state.

1. Disable the PEX 8508 upstream port's entry to L1 state for ASPM L1 [78h[1:0]] and PCI PM (device specific offset 1E0[7]) mechanisms.
2. Enable the ExtendedSync mode (Offset 78h[7]), to guarantee SKIP ordered sets are transmitted in the RcvrLck and RcvrCfg states (shown above)
