# **PEX 8533**

**PCI Express Switch**

## **Silicon Revisions and Errata List**

**Version 1.7**

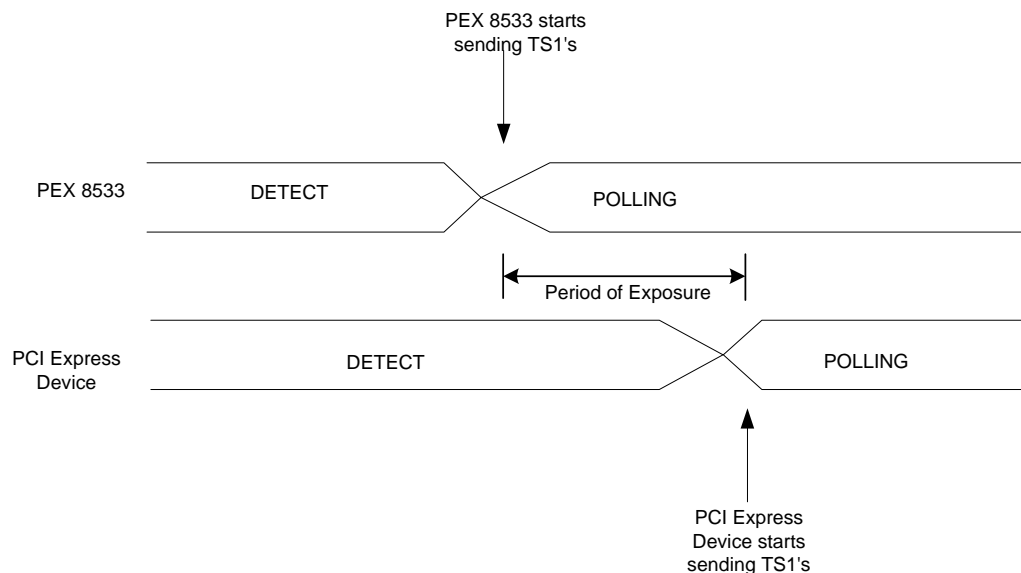
When the PEX 8533 is connected to devices that start transmitting training sets to the PEX 8533 after the PEX 8533 has been transmitting training sets (PEX 8533 in Polling state), there is a period of exposure where the receivers in the PEX 8533 are in 'electrical idle' state while the transmitters in the PEX 8533 are sending valid data. During this period, the Elastic Buffer could be set in a state that prevents the lane from participating in the final link configuration.

If the workaround is not implemented, the PEX 8533 link may down-train to a smaller width when it enters the Polling state, thus affecting performance. During link up cycles where the switch comes up in the configured width, there is no run time exposure.

1. Skew the reset inputs such that the adjacent device starts transmitting ordered sets first. The Elastic Buffer will not enter the illegal state when the PEX 8533 detects valid data on its receiver lanes during its transition from Detect state to Polling

state. For slots where it is difficult to control polling entry by skewing reset, the downstream port could be held in link down state by setting the Port Disable bits (0x236 bits 0-2) through EEPROM and enabling the port prior to discovery.

2. Re-start training sequence on link. When the adjacent device attempts to train at a link width less than its programmed width, the PLX port can be instructed to re-start its link training sequence by issuing a link disable closely followed by a link enable. The PEX 8533 link can be disabled/enabled via register 0x78 bit 4 of the appropriate port configuration space.

3. Use Different Reference clocks. The Elastic Buffer is able to recover from this condition in the Polling state when different reference clocks are used. The link will be reliable once it transitions to the Active state.

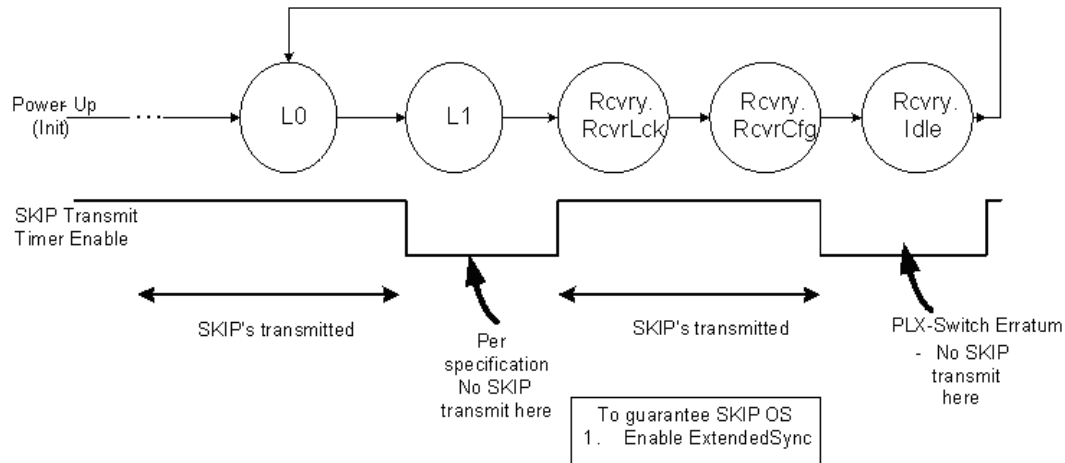
When exiting from the L1 Power Management (PM) state, there is a narrow window (recovery.idle state) during which no SKIPs are transmitted. The exit from L1 PM state steps through 3 sub-states – 1) rcvry.rcvrlock, 2) rcvry.rcvrconfig and 3) rcvry.idle. For the duration in which the link is in Recovery.idle state (waiting for receipt of 8 Idle

symbols) there will be no SKIP ordered sets transmitted. Note, SKIPs will be transmitted properly when entries into recovery sub-states are from another (L0 or L0s) state.

The Figure below illustrates the behavior.

PCI Express devices whose PHY can only deskew using SKIP ordered sets and need it to exit the recovery path shown above could fail L1 entry/exit and reach the L0 state >100ms later, taking the link down along the way. The workarounds listed above fix this, with Workaround 1 implying that the PEX 8533 will not realize any L1 power savings.

Disable the PEX 8533 upstream port's entry to L1 state for ASPM L1 [78h[1:0]] and PCI PM (device specific offset 1E0[7]) mechanisms.
