# Gate Drive Optocoupler Provides Robust Insulation in IGBT Destructive Tests

By Vladan Mitov, Applications Engineer and Chun Keong Tee, Product Manager, Avago Technologies

## White Paper

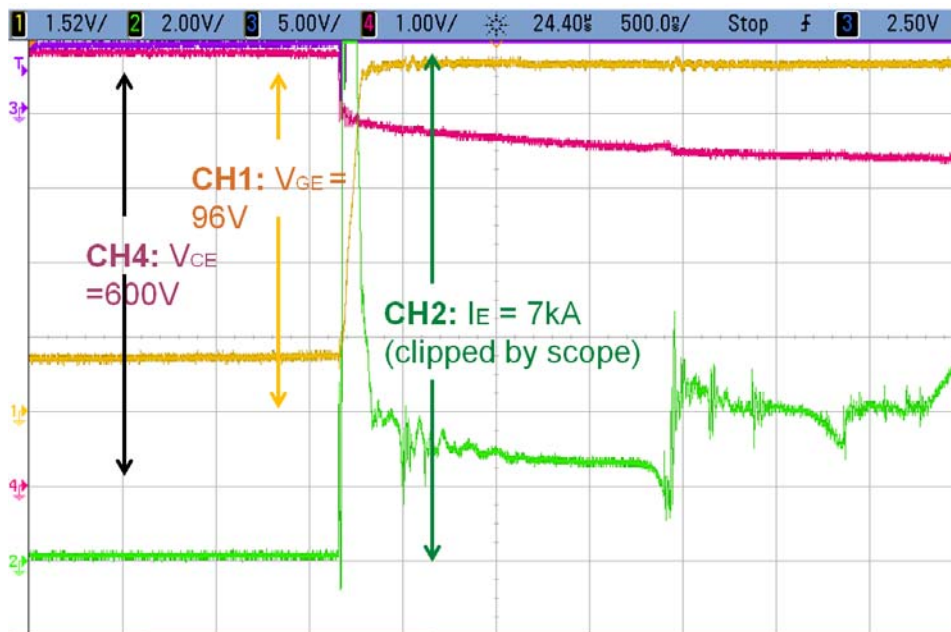
Figure 2 IGBT Short Circuit Waveforms

When short circuit occurred, the IGBT was driven into shoot through and an emitter current,  $I_E$  of 7 kA was recorded as shown Figure 2. The IGBT did not saturate ( $V_{CE}$ ) and the gate emitter voltage ( $V_{GE}$ ) increased tremendously, driving itself into thermal overload. This voltage was fed back to the ACPL-337J under test.

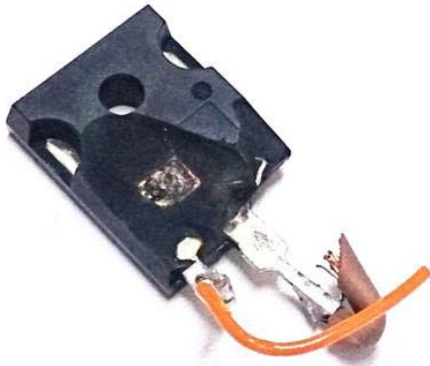
**Figure 4 The Destruction of the IGBT After Short Circuit Test**

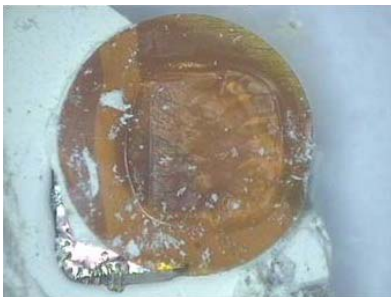
**Figure 5 The Polyimide Film of the ACPL-337J After Short Circuit Test**

Optical inspection of the polyimide film showed no damage and the insulation remained intact.

The ACPL-337J was electrically tested, and it passed the rated partial discharge test (1.88 kV<sub>RMS</sub>/s) and high voltage insulation test (6.2 kV<sub>RMS</sub>/s). Visual inspection was done externally and internally to determine the degree of damage to the insulation barrier.

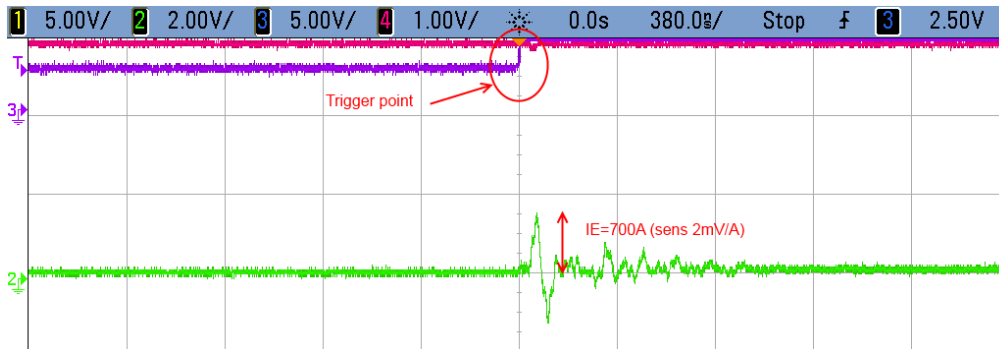
Figure 9 Direct Current Injection Waveforms

When 15 V was triggered at the gate of the IGBT, approximately 700-A emitter current was registered on the scope. This was the worst destructive test as direct energy flowed into the gate driver, causing severe damage to the gate driver board.

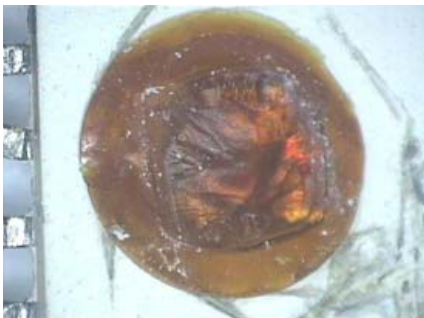
Figure 10 The Polyimide Film of the ACPL-337J After Direct Current Injection Test

The ACPL-337J was electrically tested and passed the rated partial discharge test (1.88  $kV_{RMS}/s$ ) and high voltage insulation test (6.2  $kV_{RMS}/s$ ). There was no damage to the polyimide film and the insulation remained intact.
