# **Emulex<sup>®</sup> Drivers for VMware ESXi for LightPulse<sup>®</sup> Adapters**

**User Guide  
Release 12.0**

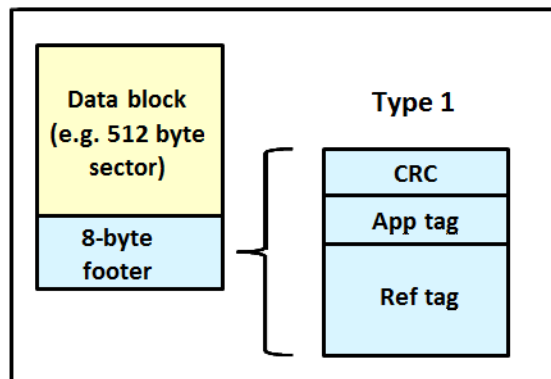
**Figure 1: Data Block Showing Type 1 DIF**

The following figure shows a data block (with a 512-byte sector) with the 8-byte footer attached to the end. The contents of the 8-byte footer are shown with the fields that make up the Type 1 DIF; the Guard Tag, the App Tag, and the Ref Tag. The App Tag is not used by the lpfc driver.

When data is written, the DIF is generated by the Host, or by the adapter, based on the block data and the logical block address. The DIF field is added to the end of each data block, and the data is sent through the SAN to the storage target. The storage target validates the CRC and Ref tag and, if correct, stores both the data block and DIF on the physical media. If the CRC does not match the data, then the data was corrupted during the write. A Check Condition is returned back to the host with the appropriate error code. The host records the error and retransmits the data to the target. In this way, data corruption is detected immediately on a write and never committed to the physical media. On a read, the DIF is returned along with the data block to the host, which validates the CRC and Ref tags. Because this validation is done by the hardware, it adds a very small amount of latency to the I/O.

The format of the Guard Tag can optionally be an IP Checksum instead of the CRC mandated by T10 DIF. This can be beneficial because the Initiator Host uses less CPU overhead to generate an IP Checksum than it does with a CRC. The IP Checksum is typically passed as the Guard Tag between the Initiator Host and the adapter. The adapter hardware will translate the IP Checksum into a CRC, or vice versa, on data being sent/received on the wire. The CRC is called a DIF protection type, and the IP Checksum is referred to as DIX protection type.

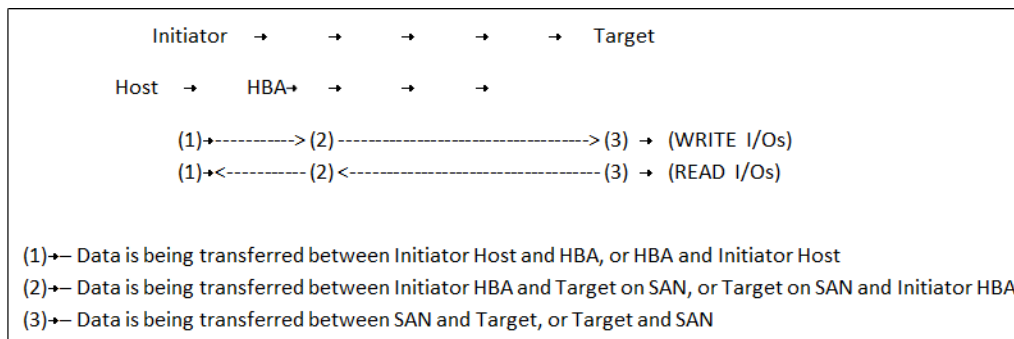
**Figure 2: Data Transfer between Initiator Host and the Adapter**

In addition, the Initiator Host will also provide the adapter with an operation code that tells the controller how to place the protection data for the type of I/O to perform. Each I/O is logically a two-step process. The data is transferred between the Initiator Host and the adapter (over the [PCI](#) bus) and between the adapter and the target (over the SAN) as shown in the following figure. The type of operation defines whether the data transfer has protection data.
