Design Notes Documentation

Product	Part Number	Description	Status
PCI 9052	PCI9052	160-pin PQFP Package	Production Released Silicon

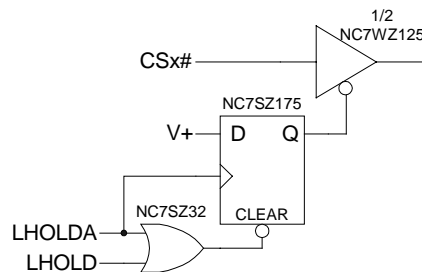
Figure 1. Disabling CSx# output when PCI9052 does not own the Local Bus

1. CS[3:0]# Chip Selects and/or ISA MEMRD# and MEMWR# signals always driven

Design Issue: The PCI 9052 always drives CS[3:0]# and/or MEMRD# and MEMWR# (in ISA mode CS[1:0]# pin functionality is MEMRD# and MEMWR#). Bus contention could occur if multiple local masters drive these signals.

Recommendation:
These signals can be isolated with three-state buffers, or a bus switch (such as a Pericom PI5C3125 (5V 4-bit bus switch)), or multiplexer (such as a Fairchild NC7SZ157). Device propagation delay of less than 3 ns is recommended.

A flip-flop can be used to enable signal output only when the PCI 9052 owns the Local bus. The active-low Output Enable input (or multiplexer Select input) of the isolation device can be driven by the output of a positive edge-triggered D-type flip-flop, as shown in Figure 1 below. Fast devices are recommended, such as the Fairchild NC7SZ175 Flip-Flop (propagation delay 2.6 ns typical), and NC7SZ32 OR gate (t_{pd} 2.4 ns typ).
