Emulex[®] Drivers for VMware ESXi

User Guide
Release 12.6

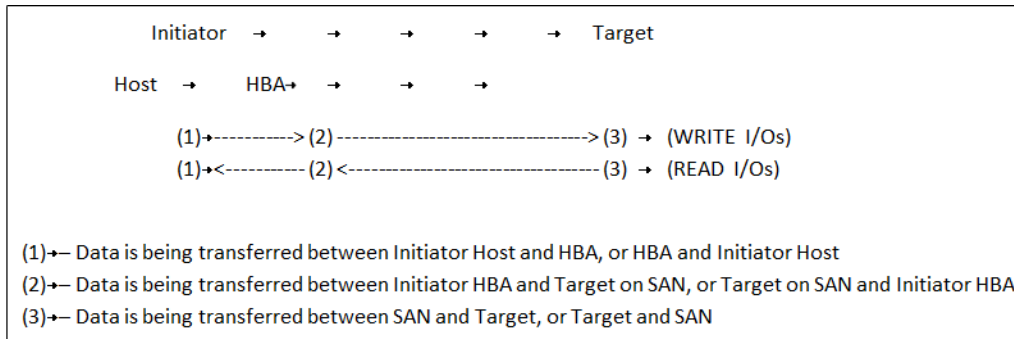
In addition, the initiator host will also provide the adapter with an operation code that tells the controller how to place the protection data for the type of I/O to perform. Each I/O is logically a two-step process. The data is transferred between the initiator host and the adapter (over the PCI bus) and between the adapter and the target (over the SAN) as shown in the following figure. The type of operation defines whether the data transfer has protection data.

Figure 2: Data Transfer between the Initiator Host and the Adapter
