# **Emulex<sup>®</sup> Drivers for VMware ESXi**

**User Guide**  
**Release 12.8**

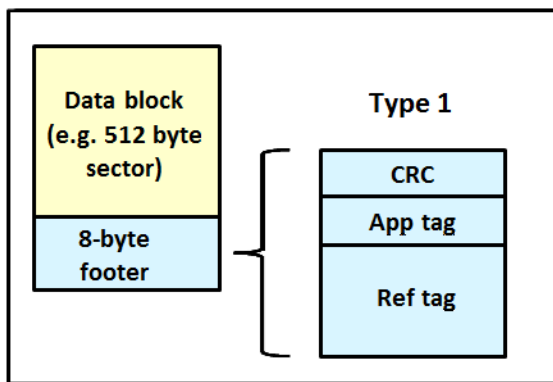
**Figure 1: Data Block Showing Type 1 DIF**

The following figure shows a data block (with a 512-byte sector) with the 8-byte footer attached to the end. The contents of the 8-byte footer are shown with the fields that make up the Type 1 DIF; the Guard tag, the App tag, and the Ref tag. The App tag is not used by the `lpfc` driver.

When data is written, the DIF is generated by the host, or by the adapter, based on the block data and the LBA. The DIF field is added to the end of each data block, and the data is sent through the SAN to the storage target. The storage target validates the CRC and Ref tag and, if correct, stores both the data block and DIF on the physical media. If the CRC does not match the data, the data was corrupted during the write. A Check Condition is returned to the host with the appropriate error code. The host records the error and retransmits the data to the target. In this way, data corruption is detected immediately on a write and is never committed to the physical media. On a read, the DIF is returned along with the data block to the host, which validates the CRC and Ref tags. Because this validation is done by the hardware, it adds a very small amount of latency to the I/O.
