Application Note 5592

Introduction to CDB (Common Data Block)

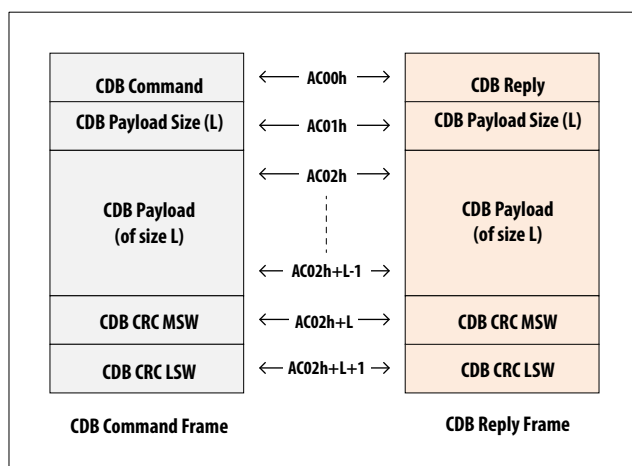
Figure 13. Common Data Block Structure

CFP MSA MIS 2.2 r06a allocates 1024 registers on A000h page as the CDB which starting at AC00h and ending at AFFFh. It has two realizations, the CDB Command Frame (Panel A) and the CDB Reply Frame (Panel B). When host requests module to perform a task it writes a CDB Command Frame to the module. When host requests the status of last command execution with optional data return; it reads a CDB Reply Frame from the module. See Figure 13 Common Data Block Structure in CFP MSA MIS 2.2. CDB Command Frame includes CDB Command Register, CDB Payload Size Register, CDB Payload Registers and CDB CRC Registers.

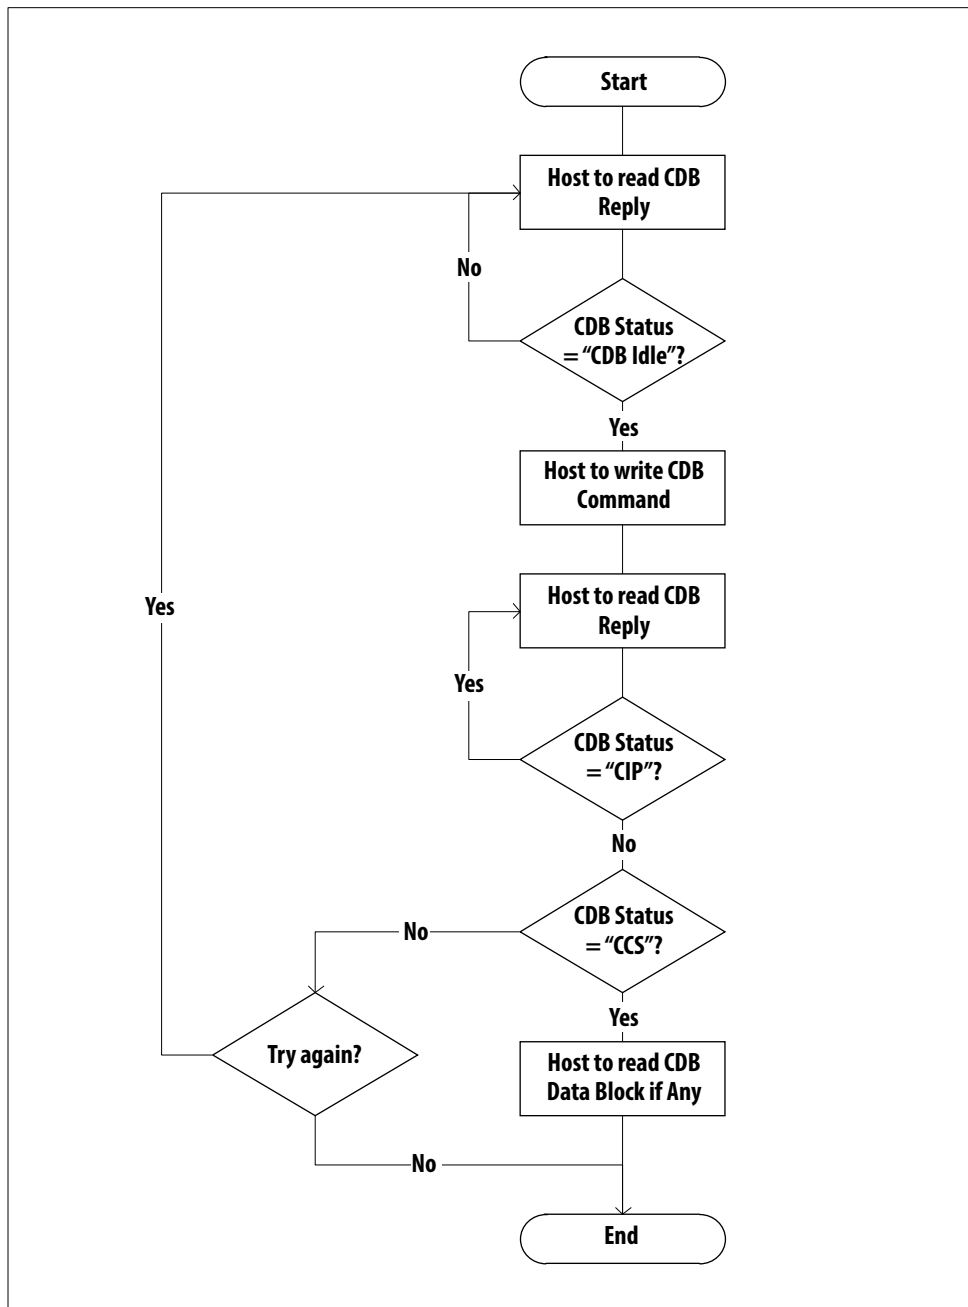
Figure 14. CDB Command Execution Flowchart

CDB Command execution is an interactive process between host, CDB State Machine, and module processor. Figure 2 CDB Command Execution Flowchart illustrates the process of host execution. Note that CDB Reply is used extensively in CDB Command execution process.

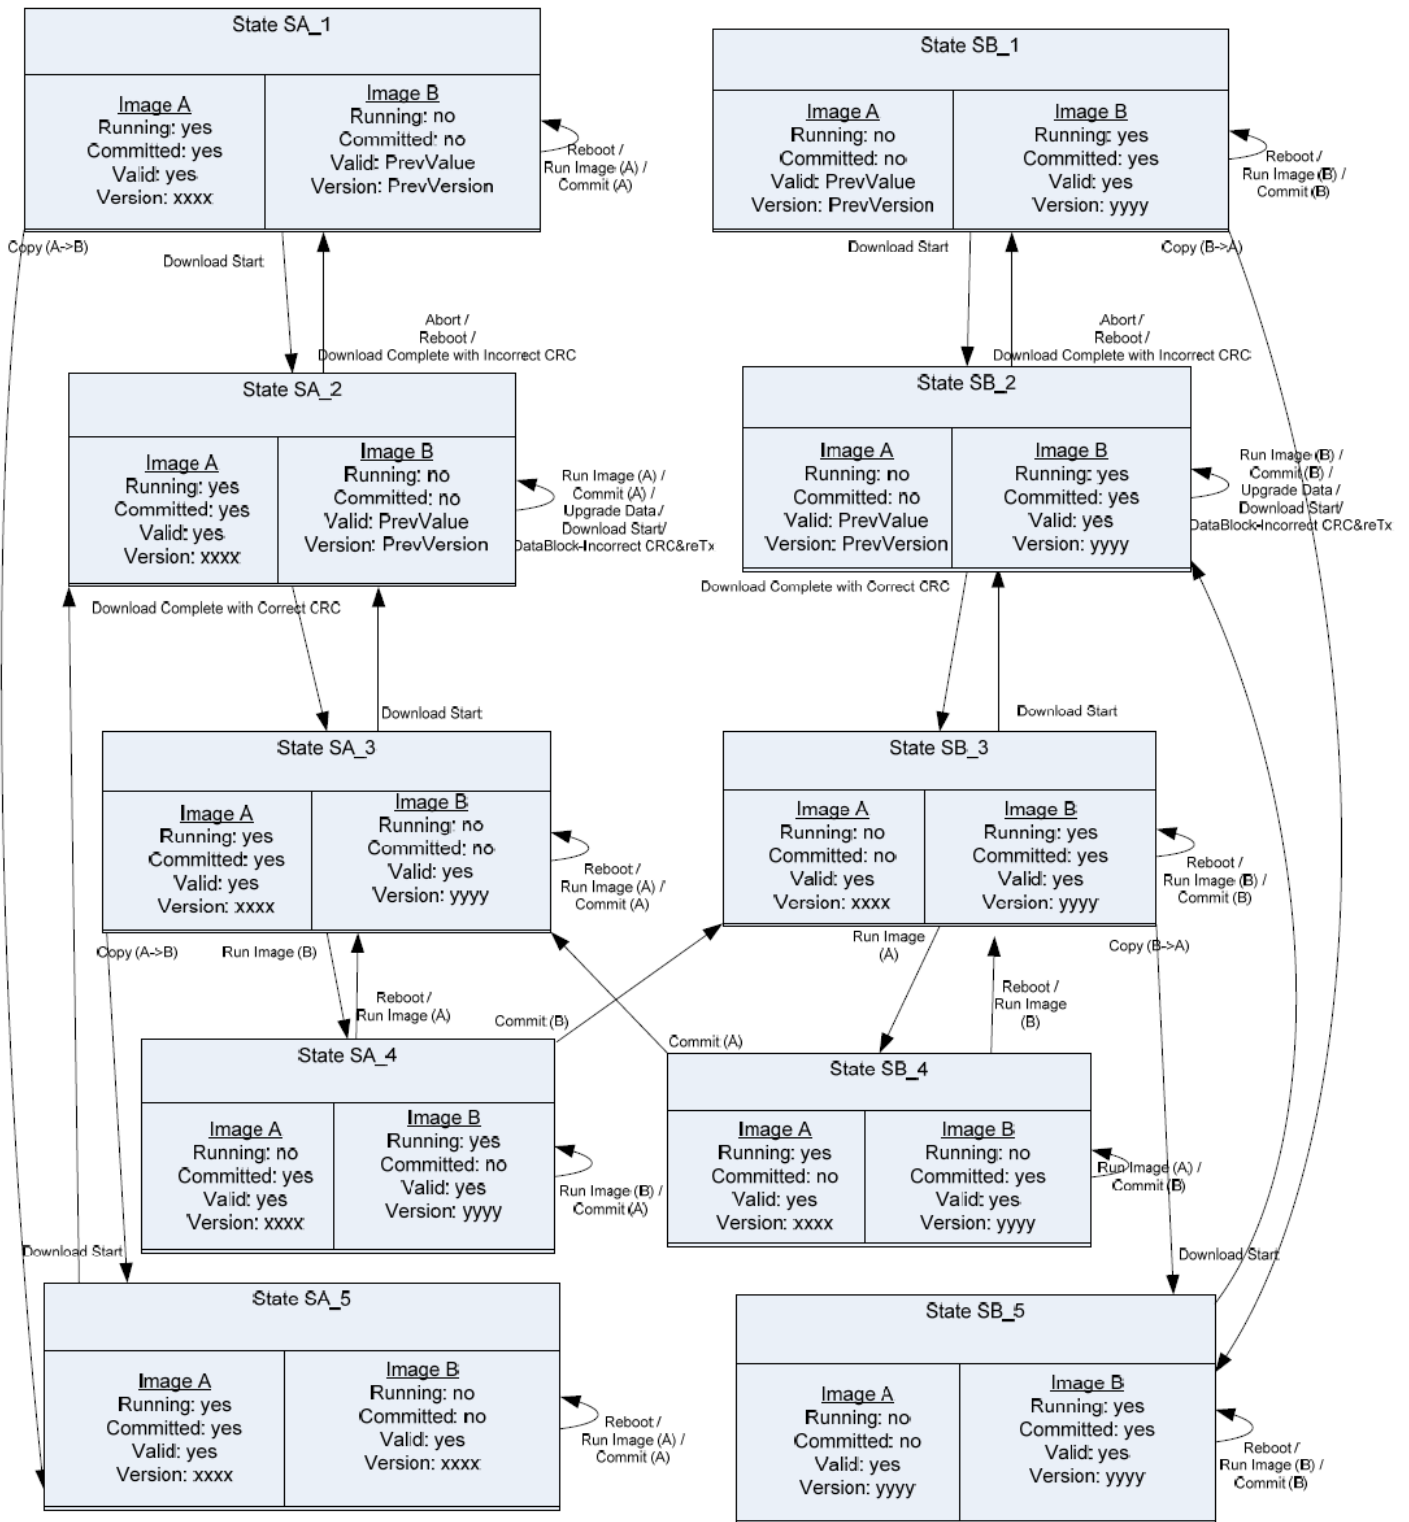
Figure 19. Software Upgrade State Machine.

A software upgrade transfer begins with the Host issuing a request to download an image. The module grants the request and the image is written a block at a time and setting the "Upgrade Data Block Ready" flag and the module processes each block and updates the status. It is the host responsibility to make sure that each block size is equal to or less than the "Maximum Upgrade Data Block Size". If there is any error in block processing, the host will retransmit the block. It is recommended to force an abort by the host if a CRC error occurs few times on the same block. While download is not complete, the Host can issue "Abort" command to abort the current download that is in progress. After all the works of the image have been written to the module, termination of the transfer is completed by issuing a Download Complete to the Upgrade Command register. The module will acknowledge the complete image has been downloaded successfully by providing a Command completed successfully status. If the image has an error in download, then the module will reply with a Command failed status. This state machine is illustrated in Figure 19 Software Upgrade State Machine. The Software Upgrade sequence is illustrated in. Modules sets - Maximum Upgrade Data Block Size.

Firmware upgrade procedure can refer to Figure 19 Software Upgrade State Machine and Figure 20 Software Upgrade Sequence with exception that copy commands are not supported.
