Fabric OS
v9.2.0c/v9.2.0c1/v9.2.0c2/v9.2.0c3/v9.2.0c4/v9.2.0c5
Fabric OS v9.2.0c Release Notes Digest

Version 8.0

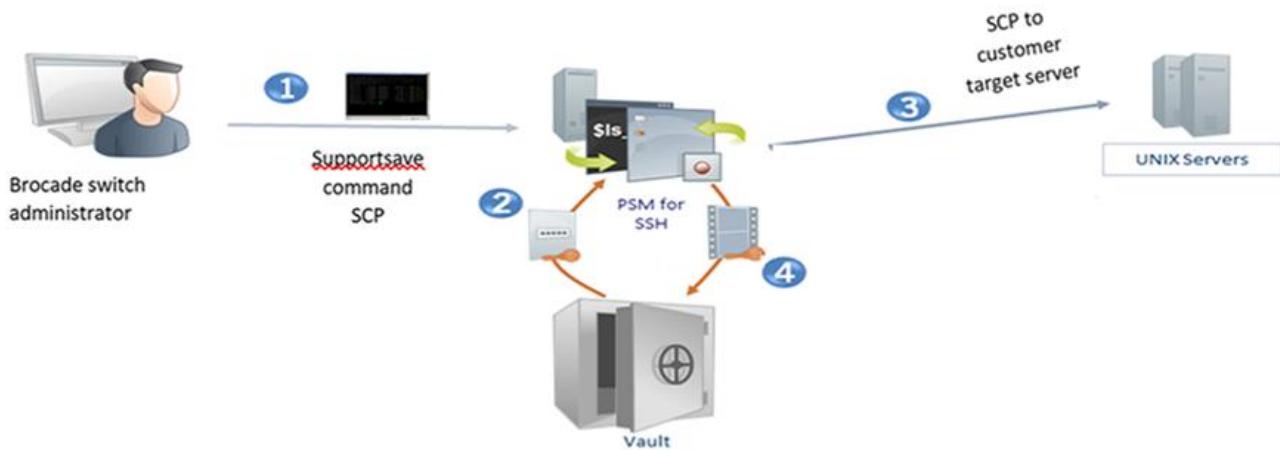
FOS users will not have credentials to access the remote repository server to transfer the files. Credentials for remote servers are stored in the Cyberark vault. In which case, the user must access the server through PSM for SSH provided by Cyberark.

For example, let's say *RepositoryUser* is the user in remote server *Repository.server.net* whose credentials are not known to the switch user. It is stored in the Cyberark vault *CyberArk.psm.server.net*. The switch user has credentials *CyberArkUser* to be validated and authorized by the CyberArk PSM server to access the Repository server. The switch user can then access the remote Repository server using the following command format:

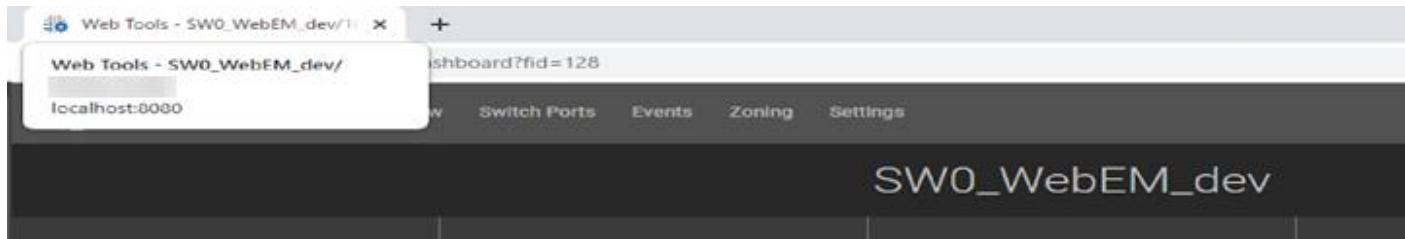
With FOS v9.2.0, after successful login with Web Tools, the browser's title bar will display Web Tools – Switch Name / Switch IP Address.

Example:

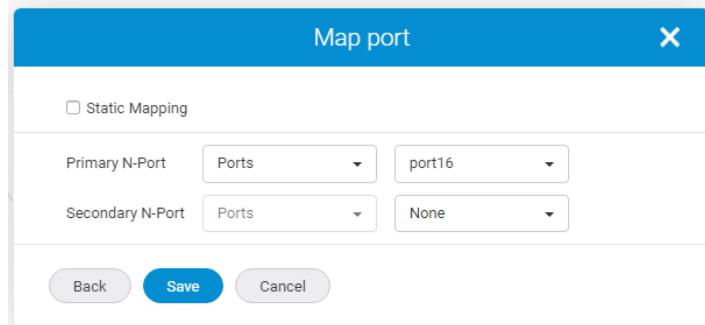
By default, the secondary N-port will have the value None.

Example:
