Fabric OS® v9.2.2a

Fabric OS v9.2.2a Release Notes Digest

Version 1.0

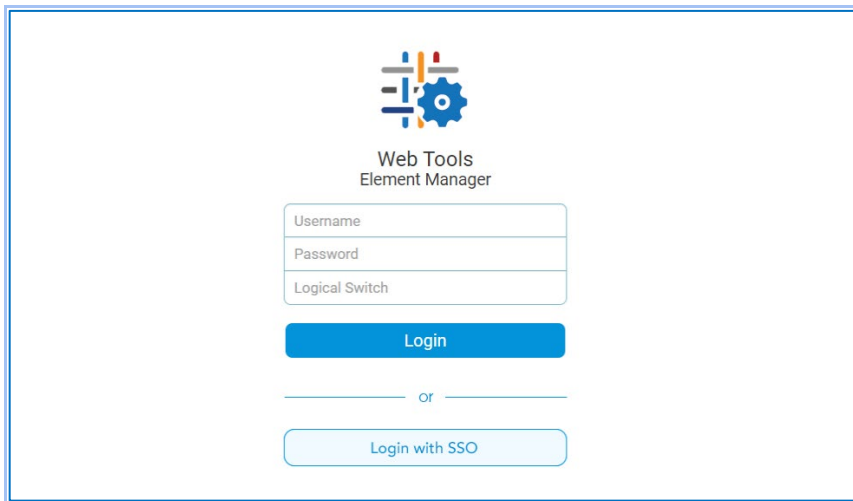
Login screen example:

The image shows the login interface for 'Web Tools Element Manager'. At the top is a logo consisting of a gear and a vertical bar with colored segments. Below the logo, the text 'Web Tools Element Manager' is centered. There are three input fields: 'Username', 'Password', and 'Logical Switch'. Below these fields is a blue 'Login' button. Underneath the button is the word 'or' flanked by horizontal lines. At the bottom is a light blue 'Login with SSO' button.

1. User clicks on “Login with SSO” button
2. Browser page is redirected to Web Tools Dashboard landing page

After successful login, the FA user which is used for authentication will be shown in the user info section.

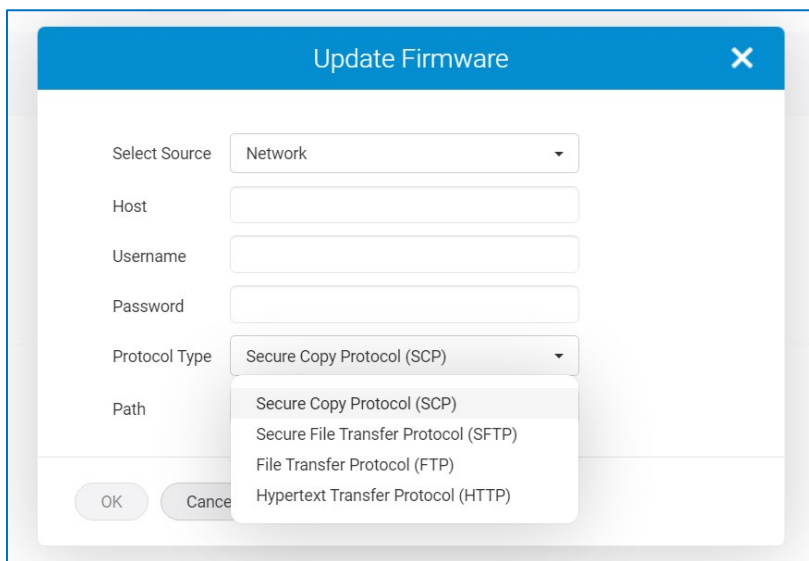
In the example below shown for Update Firmware.

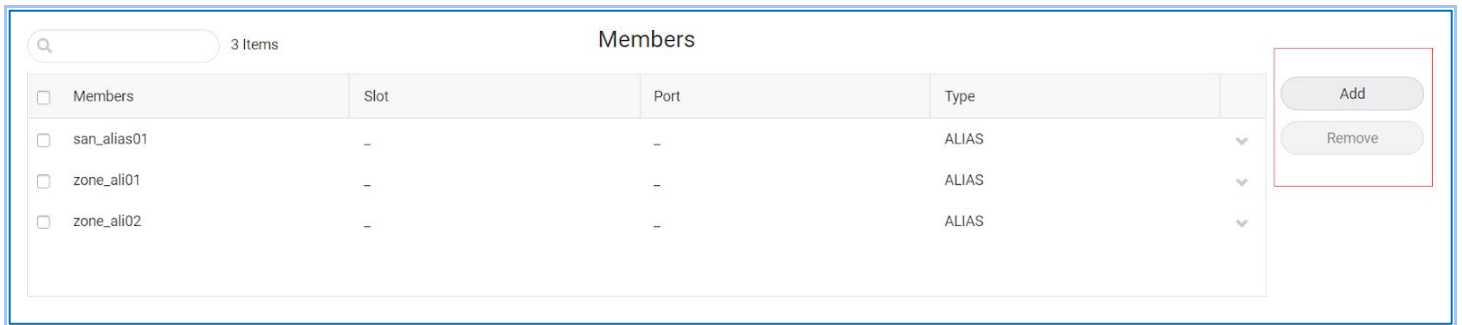
In previous FOS versions the menu buttons were placed right to the table and the table could not use the full available width even though there were no menu buttons.

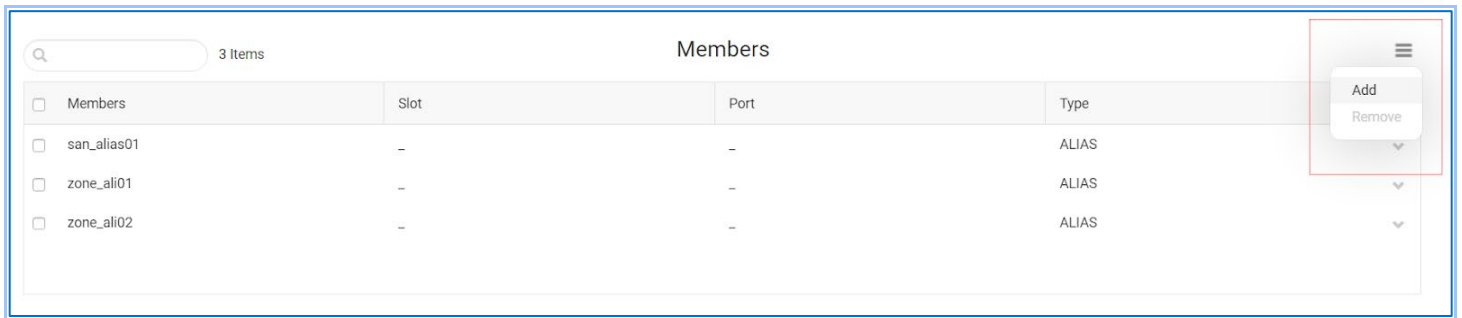
In FOS v9.2.2 the table action button is moved into the table hamburger menu and the table width is maximized to occupy the page.
