Fabric OS v9.2.2c/v9.2.2c1

Fabric OS v9.2.2c Release Notes

Version 3.0

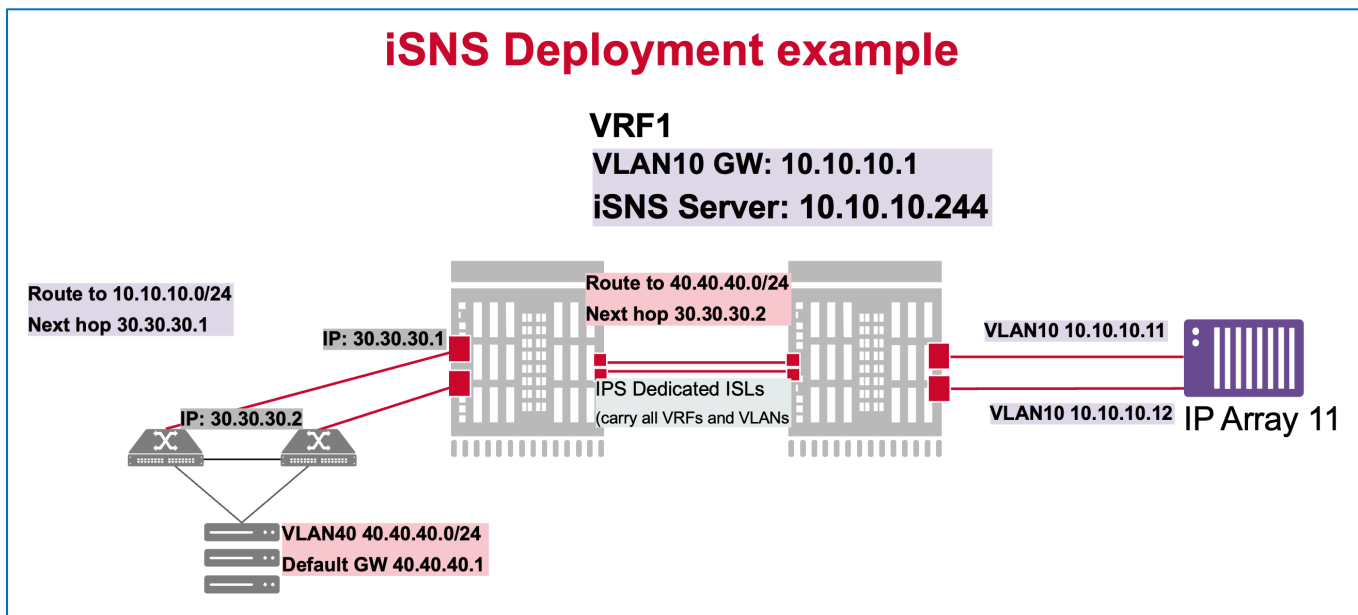
Figure 1: iSNS Deployment Example

Figure 1 depicts a topology with a typical iSNS deployment. The iSNS server virtually resides within one of the VLANs in the VRF using one dedicated IP address in the respective VLAN.

Recommended best practice is to use a storage VLAN to host the iSNS server IP address to ensure no additional static routes are required from associated host subnets (although technically any VLAN for a given VRF can be used).

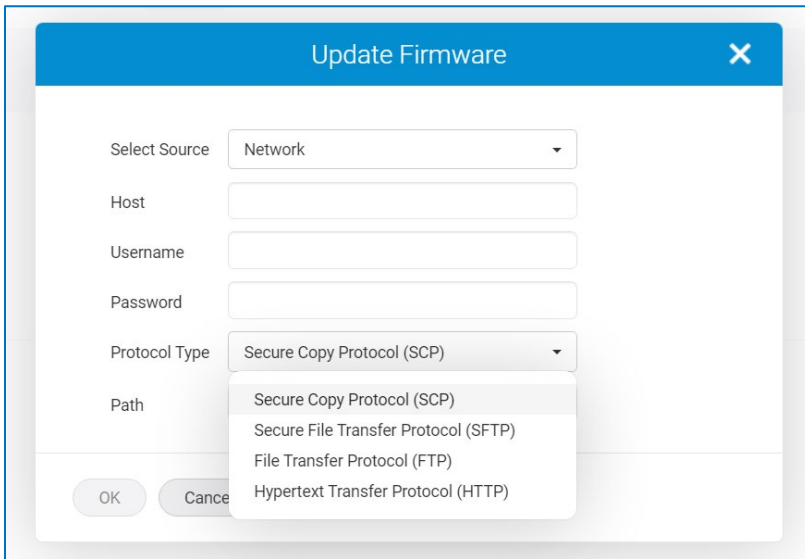
In the example below shown for Update Firmware.
