# **Emulex® HBA Manager Application for Linux**

## **Releases 12.8.542.28-1 and 12.8.542.31-1**

These release notes describe the new features, resolved issues, known issues, and technical tips associated with this release of the Emulex® HBA Manager application for Linux.

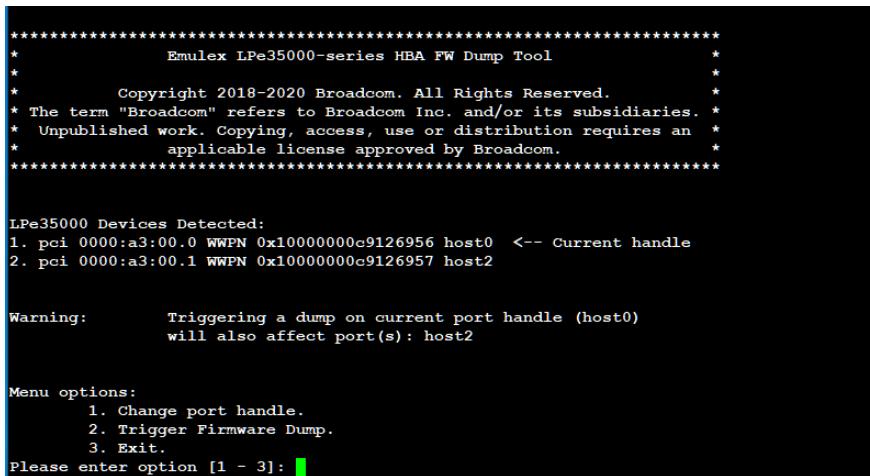
A window similar to the following is displayed.

```
*****
*          Emulex LPe35000-series HBA FW Dump Tool
*
*          Copyright 2018-2020 Broadcom. All Rights Reserved.
*          The term "Broadcom" refers to Broadcom Inc. and/or its subsidiaries.
*          Unpublished work. Copying, access, use or distribution requires an
*          applicable license approved by Broadcom.
*****
```

LPe35000 Devices Detected:

1. pci 0000:a3:00.0 WWPN 0x10000000c9126956 host0 <-- Current handle
2. pci 0000:a3:00.1 WWPN 0x10000000c9126957 host2

Warning: Triggering a dump on current port handle (host0)  
will also affect port(s): host2

```
tar xzf elx-lpe-35000-fw-dump-tool-<version>-ds-1.tar.gz
cd elx-lpe-35000-fw-dump-tool-<version>-ds-1/
rpm -ivh elx-lpe-35000-fw-dump-tool-<version>.<platform>.rpm
```

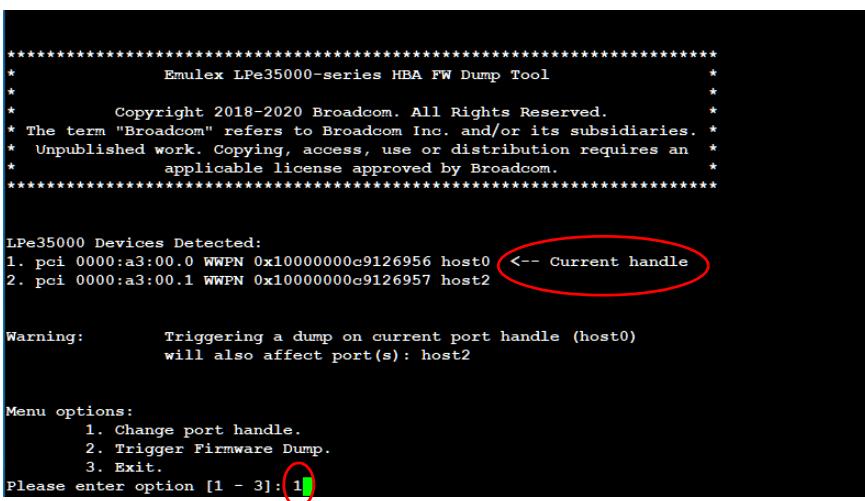
2. Type 1 and press **Enter** to select the port for which you want to perform the firmware dump.

A window similar to the following is displayed.

```
*****
*          Emulex LPe35000-series HBA FW Dump Tool
*
*          Copyright 2018-2020 Broadcom. All Rights Reserved.
*          The term "Broadcom" refers to Broadcom Inc. and/or its subsidiaries.
*          Unpublished work. Copying, access, use or distribution requires an
*          applicable license approved by Broadcom.
*****
```

LPe35000 Devices Detected:
